ROBENA SLURRY POND 6

UNITED STATES STEEL CORPORATION
RAW MATERIALS DIVISION
FRICK DISTRICT

PHASE I INSPECTION REPORT
NATIONAL DAM INSPECTION PROGRAM

411785
JULY 1981

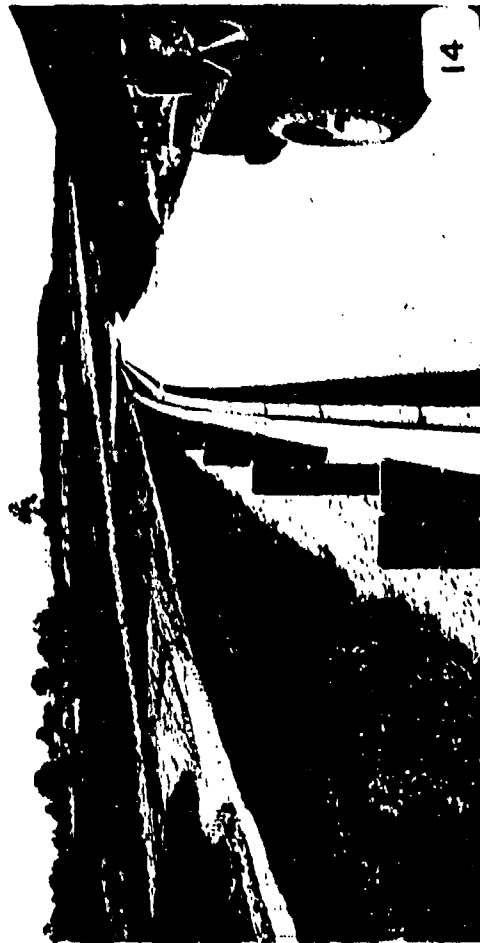
- Photo 1 Downstream Overview from embankment crest showing yellow boy pond, Slurry Pond 4, and Robena preparation plant.
- Photo 2 Embankment Toe Overview showing access road embankment and culvert, principal spillway outlet, and downstream slope benches.
